Memorandum

Subject: Safety Concerns at the Intersection of Lynnwood Drive and Hoezle Road in Mercer County

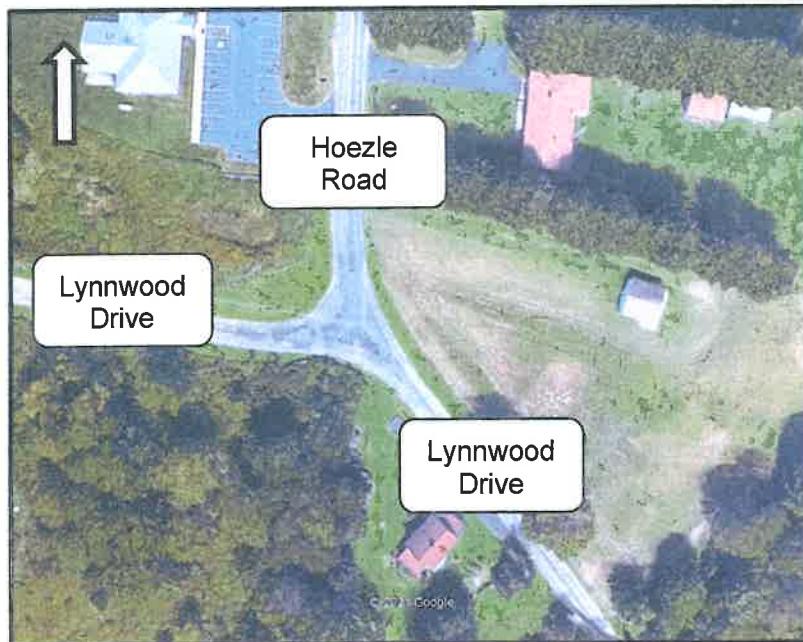
Figure 1: Lynnwood Drive at Hoezle Road

The intersection of Lynnwood Drive and Hoezle Road is currently a one-way stop. Lynnwood Drive is two-way and both approaches are uncontrolled. Hoezle Road is two-way and the approach is stop controlled. The posted speed on Lynnwood Drive is 35

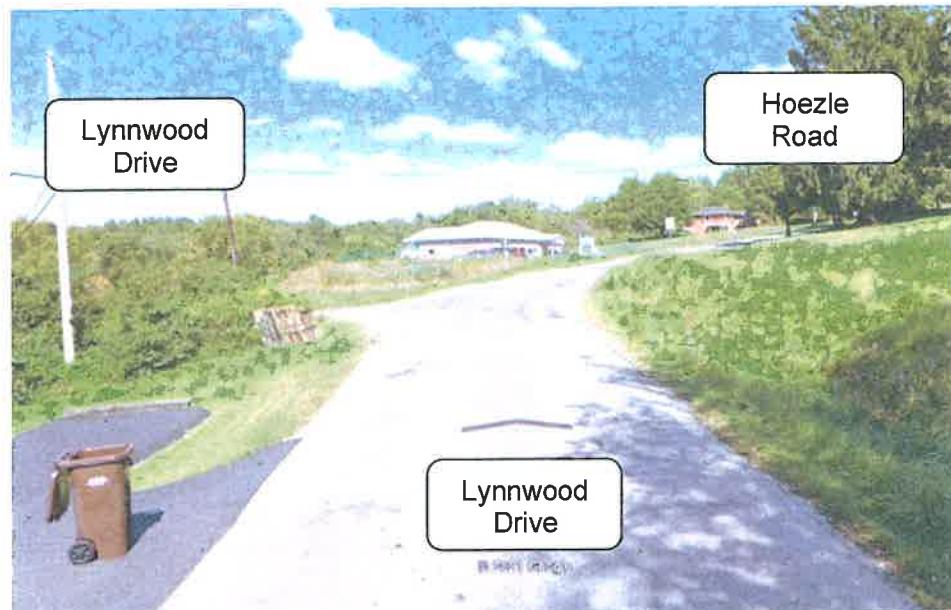
The City was concerned with sight distance for vehicles attempting to make left turns from Lynnwood Drive onto Hoezle Road. The sight distance is limited for both approaches on Lynnwood Drive due to both overgrown vegetation, roadway grade, and horizontal geometry.

Figure 5: Lynnwood Drive Westbound approach looking at the intersection.

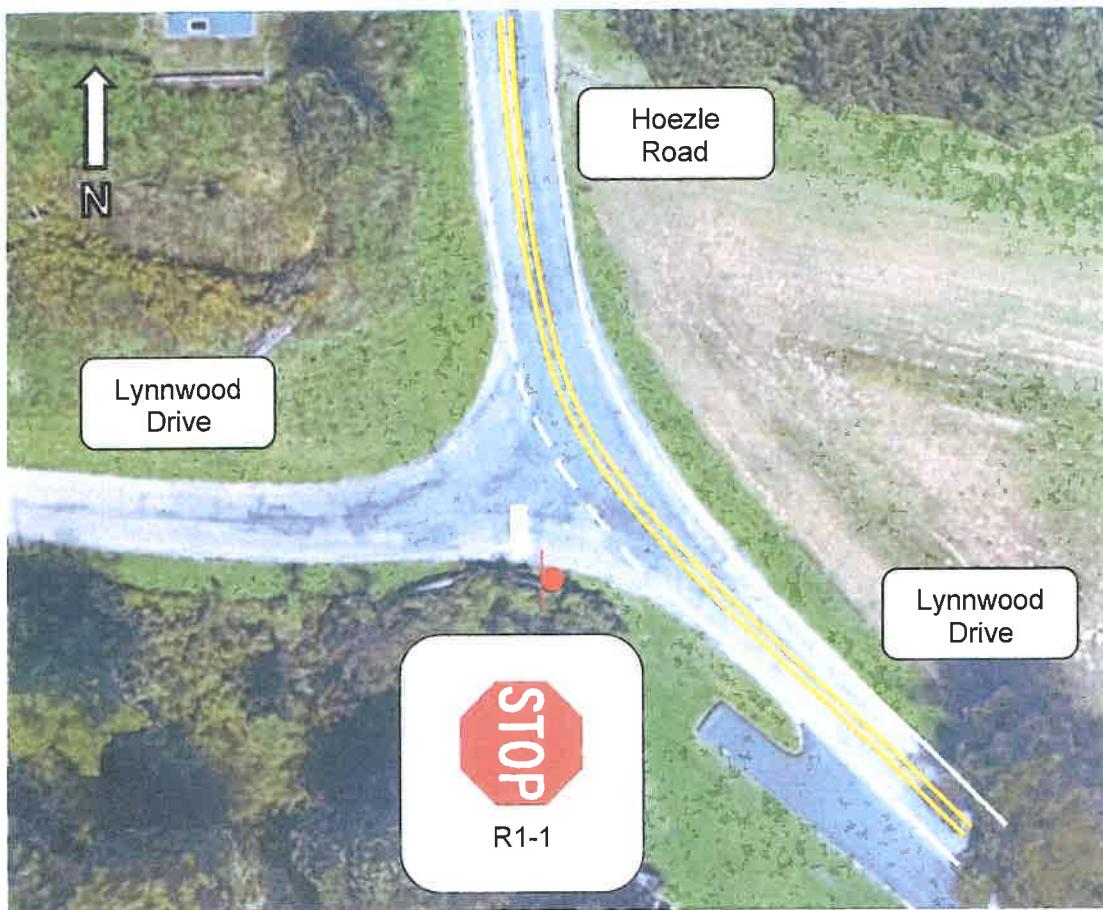
Figure 7: Proposed low-cost safety improvements at Lynnwood Dr and Hoezle Rd.

- Trim the overgrown vegetation behind the guiderail to improve overall sight distance at the intersection.
- Due to roadway geometry, relocate stop control from the Hoezle Rd approach to Lynnwood Dr to control traffic moving eastbound and remove old stop sign. Since there is a sight distance issue here that is partially due to the geometry and grade of the roadway, the main road and right-of-way could be given to Lynnwood Dr westbound to Hoezle Rd northbound. The vehicles approaching from Lynnwood heading eastbound already slow down or stop due to the sight distance issue. In addition to installing a Stop Sign (R1-1), install a Stop Ahead Sign (W3-1), and place a stop bar pavement marking as shown in Figure 7. Pavement markings (including both centerline and edge lines) are another low-cost improvement that can be added to improve safety at the intersection by clearly delineating the right-of-way.
